**Flood Control Project Maintenance  
Levee Inspections**  
**LMA District Cover Sheet**  
**Spring 2019 Levee Inspection Results**

**Reclamation District No. 0501 Ryer Island**

**Spring 2019 Levee Inspection Results**

**Levee Inspection Report By Mile - Spring 2019**

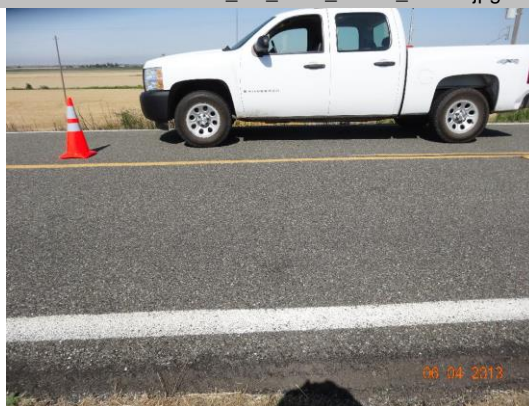
Photo 1 of 3 : UCIP\_SP\_2019\_32524\_58928.jpg

Comment Code						
Inspector Comment						
FS_ID:32524 DS_ID:21031 EP_NO: N/A Repair Type: Non-Urgent Crossing Status: Found UCIP Comments: Dense vegetation limits the inspector's visibility to identify signs of leaks through the slope. Recommend removing vegetation along pipe alignment for reinspection. Need to contact the owner to clear slope along crossing. FIELD_STRUCT_DESC: 20-inch irrigation discharge pipe of an unknown material and a 2.5-inch electrical conduit of an unknown material through the levee, both 7.8 feet below the crown. Pump and gate valve in a pump house on the landside (LS) slope. Pipe exposed along the waterside (WS) slope. [Additional Reference(s): DWR Levee Log, 2005. USACE Sacramento O&M Manual 105, April 1959, (HLM 0.4), irrigation siphon referenced]. FS Date: 6/4/2013

View of crown

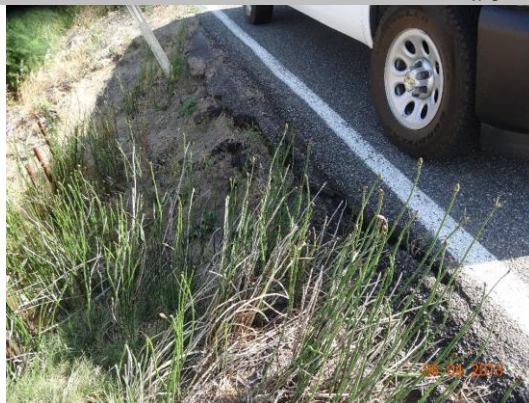
Photo 3 of 3 : UCIP\_SP\_2019\_32524\_58925.jpg

Comment Code						
Inspector Comment						
FS_ID:32524						
DS_ID:21031						
EP_NO: N/A						
Repair Type: Non-Urgent						
Crossing Status: Found						
UCIP Comments: Dense vegetation limits the inspector's visibility to identify signs of leaks through the slope. Recommend removing vegetation along pipe alignment for reinspection. Need to contact the owner to clear slope along crossing.						
FIELD_STRUCT_DESC: 20-inch irrigation discharge pipe of an unknown material and a 2.5-inch electrical conduit of an unknown material through the levee, both 7.8 feet below the crown. Pump and gate valve in a pump house on the landside (LS) slope. Pipe exposed along the waterside (WS) slope. [Additional Reference(s): DWR Levee Log, 2005. USACE Sacramento O&M Manual 105, April 1959, (HLM 0.4), irrigation siphon referenced].						
FS Date: 6/4/2013

Crown hinge point damaged, roadway section missing.

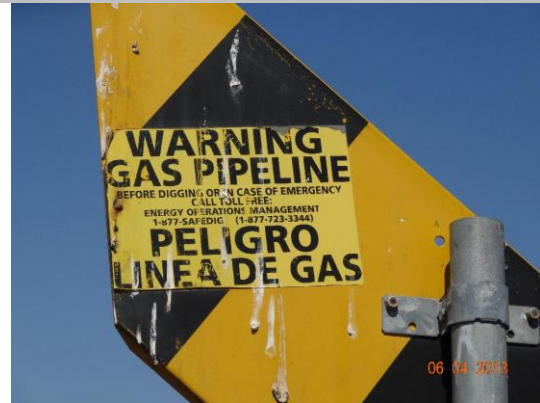
Photo 3 of 3 : UCIP\_SP\_2019\_41409\_58932.jpg

Comment Code						
Inspector Comment						
FS_ID:41409 DS_ID:21032 EP_NO: N/A Repair Type: Non-Urgent Crossing Status: Found UCIP Comments: Need to contact owner and ask for emergency contact information and permit number. 8/21/13 Contacted Gas Control Division under the emergency contact No. 1-877-723-3344. Message has been forward to Brian Habersack at 916-859-4700, email: bhabersack@gasbiz.com. FIELD_STRUCT_DESC: 6-inch steel natural gas pipeline under the levee, 60 feet below the crown. Gas line marker on each shoulder. (Plans to install a 6-inch steel natural gas pipeline across and bored under the channel and each levee authorized under Permit No. 17033, 1999 - Delta Gas Gathering, Inc., and A. A. Production Services, Inc.). [Additional Reference(s): DWR Levee Log, 2005]. FS Date: 6/4/2013

Gas line contact information on the sign.

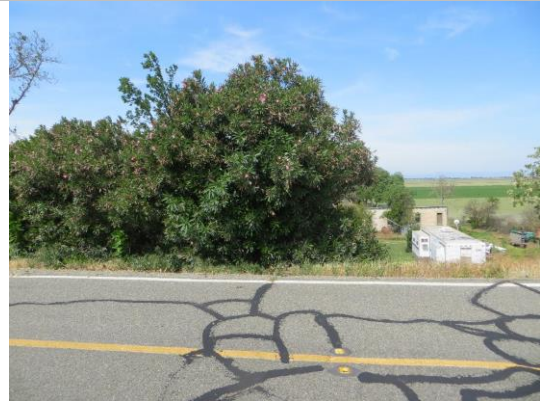
Photo 3 of 3 : UCIP\_SP\_2019\_44643\_73840.jpg

Comment Code						
Inspector Comment						
FS_ID:44643 DS_ID:21089 EP_NO: 2683 Repair Type: Non-Urgent Crossing Status: Indicator Found UCIP Comments: Appears abandoned and if so should be done so properly. FIELD_STRUCT_DESC: *ABANDONED* 2-inch steel water pipe and a 1-inch steel electrical conduit through the levee, both 3 feet below the crown. Portion of pipe visible under the oleanders on the landside (LS) shoulder, may be part of this crossing. No evidence remains on the waterside (WS) slope. (Plans for installation of an electrical conduit and a water pipe through the levee authorized under Permit No. 2683, 1957 - John Gosner). FS Date: 4/21/2015

Pipes visible under oleander on LS shoulder.

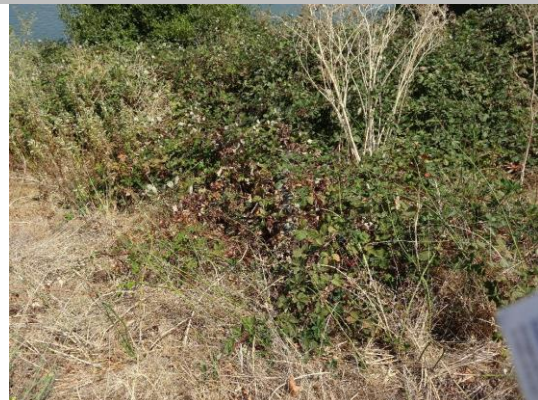
Photo 3 of 3 : UCIP\_SP\_2019\_50020\_75645.jpg

Comment Code						
Inspector Comment						
FS_ID:50020 DS_ID:21034 EP_NO: N/A Repair Type: Non-Urgent Crossing Status: Found UCIP Comments: 8/22/2016 Crossing has been downgraded from Urgent to Non-Urgent -- no evidence of damage to levee is present. Dense vegetation limits the inspector's visibility to identify signs of pipe failure (leaks) through he slope. Recommend removing vegetation along pipe alignment to conduct proper inspection of structure and appurtenances. Also will need to coordinate with owner to determine if permit was obtained for the modifications made to crossing (PVC pipe sleeved through existing pipe). (DWR UCIP - omagana)4/21/2015 Unauthorized PVC pipe. Annular space not grouted. 14-inch pipe open on both ends. (DWR UCIP - omagana) FIELD_STRUCT_DESC: 14-inch steel irrigation siphon pipe through the levee, 3.2 feet below the crown. 10-inch polyvinyl chloride (PVC) pipe sleeved through the 14-inch pipe. Siphon breaker on the landside (LS) shoulder. [Additional Reference(s): DWR Levee Log, 2005. USACE Sacramento O&M Manual 105, April 1959, (HLM 1.0)]. FS Date: 8/22/2016

Dense vegetation covers WS--pipe slightly visible through vegetation.

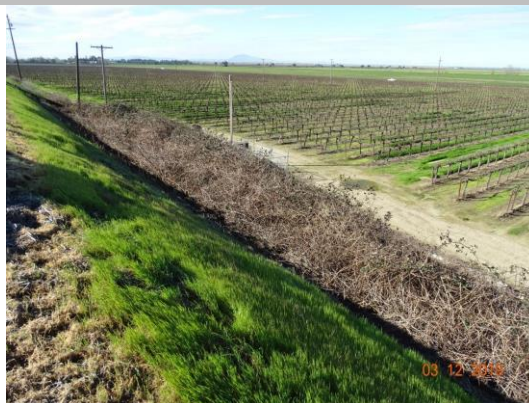
Photo 1 of 1 : SP\_2019\_RD0501\_169\_35\_20190314\_00068.jpg

View looking downstream at blackberries on the landside toe (Spring 2019).

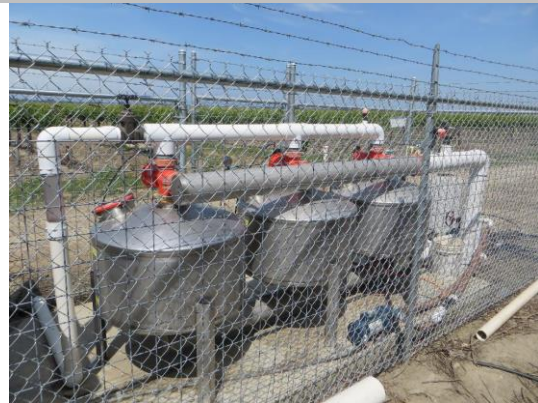
Photo 1 of 3 : UCIP\_SP\_2019\_47516\_73857.jpg

Comment Code					
Inspector Comment					
FS_ID:47516 DS_ID:21086 EP_NO: 13233 Repair Type: Non-Urgent Crossing Status: Found UCIP Comments: Annular space between pipes not grouted. FPIIB Inspector Herman Phillips will contact owner regarding lack of permit for sand filters. Steel plate partially covers openings between pipes. FIELD_STRUCT_DESC: 14-inch coated steel irrigation discharge pipe through the levee, 2.5 feet below the crown. 8-inch steel pipe sleeved through the 14-inch pipe. Cutoff wall around the pipe at the center of the levee. Pump and check valve in a pump house on the waterside (WS) slope. Service pole on the landside (LS) slope. A 1.5-inch and a 2.5-inch electrical conduits at the same location. Siphon breaker on each shoulder. (Plans to replace a 12-inch irrigation pipe through the levee authorized under Permit No. 11813, 1976 - Harry H. Rasmussen. Plans to replace irrigation pipe with a 14-inch pipe through the levee authorized under Permit No. 13233, 1981 - Harry H. Rasmussen. Plans to install an 8-inch steel pipe through an existing 14-inch pipe through the levee authorized under Permit No. 11813-1, 2013 - Matt Davis). FS Date: 4/21/2015

Sand filter plant on LS toe.

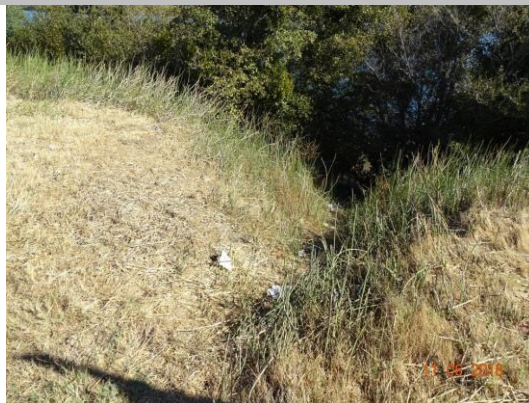
Photo 1 of 2 : SP\_2019\_RD0501\_169\_47\_20190311\_00013.jpg

LM Start	2.07	Rating **	U	Issue No.	47
LM End	2.07	Issue Type +	Ma	Location *	WS
Category	Earthen Levee			GPS Latitude/Longitude	
				Start	End
Item	Slope Stability			38.225070 °	38.225070 °
				-121.603827 °	-121.603827 °
DWR ID	DWR_RD0501_01_f_2018_47				
Comment Code					
S2 : Repair the levee slope damaged by foot traffic and prevent access where possible.					
Inspector Comment					
Deep gouges in the waterside slope due to heavy foot traffic. LMA put sign up to deter foot traffic and it has been effective.

View of foot path that is more than 1 foot deep into the waterside slope (November 2018).

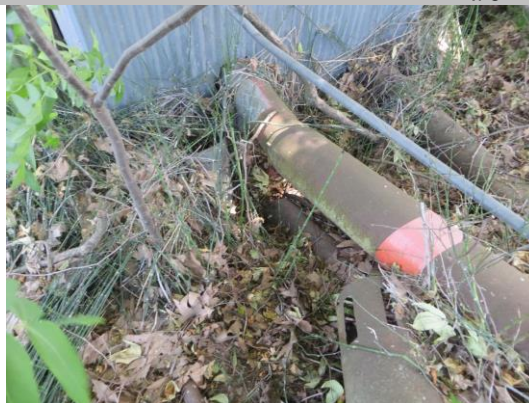
Photo 3 of 3 : UCIP\_SP\_2019\_44683\_73880.jpg

Pipe, conduit, and pipe debris on WS slope.

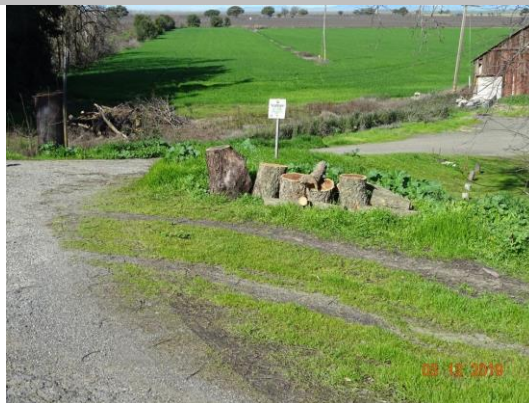
Photo 1 of 1 : SP\_2019\_RD0501\_169\_65\_20190314\_00070.jpg

View of firewood logs on the landside shoulder (Spring 2019).

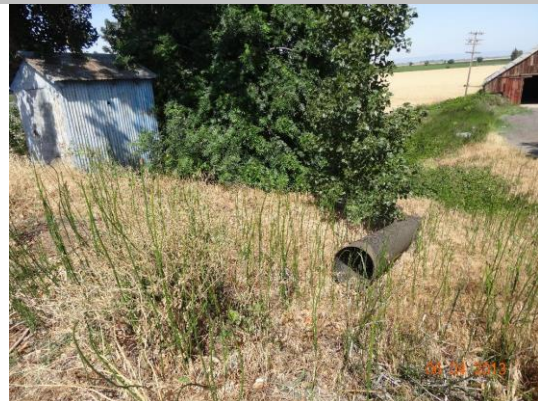
Photo 2 of 3 : UCIP\_SP\_2019\_32526\_58935.jpg

Pump house on landward slope. An abandoned pipe section on landward slope.

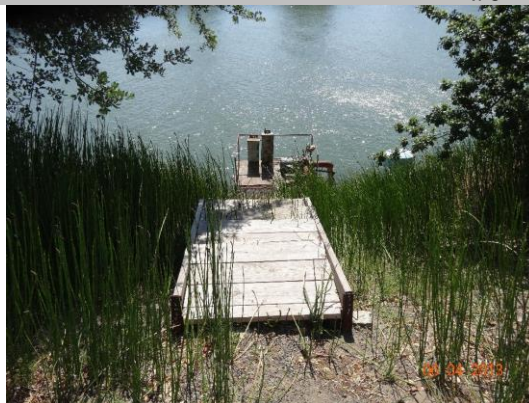
Photo 2 of 3 : UCIP\_SP\_2019\_53351\_58940.jpg

Station details--gate valve, air vent, and other appurtenances.

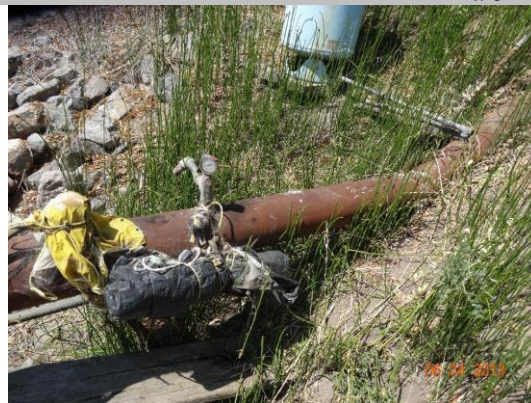
Photo 3 of 3 : UCIP\_SP\_2019\_53351\_58945.jpg

View of waterward side--pressure gauge, conduit, and wraps to prevent leaks.

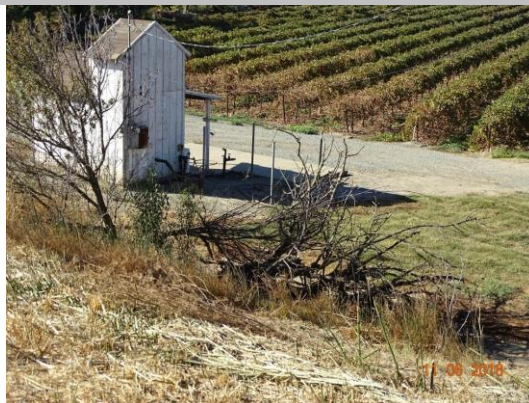
Photo 1 of 1 : SP\_2019\_RD0501\_169\_61\_20190311\_00016.jpg

View of downed tree on the landside toe (November 2018).

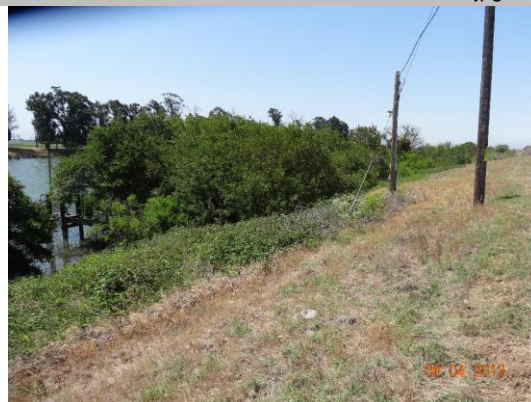
Photo 2 of 3 : UCIP\_SP\_2019\_19644\_33331.jpg

Overview of waterward side--pump station, platform, & power pole.

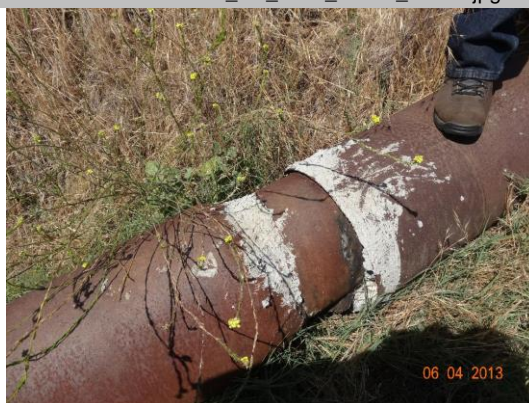
Photo 3 of 3 : UCIP\_SP\_2019\_19644\_33326.jpg

12-inch pipe sleeved through existing 14-inch pipe, and annular space grouted--waterward side.

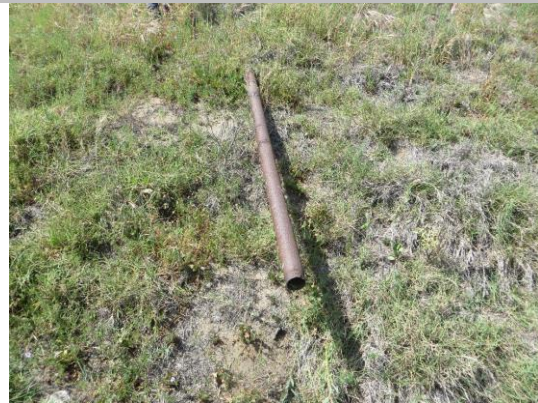
Photo 1 of 3 : UCIP\_SP\_2019\_50024\_73901.jpg

2.5-inch conduit visible on WS slope.

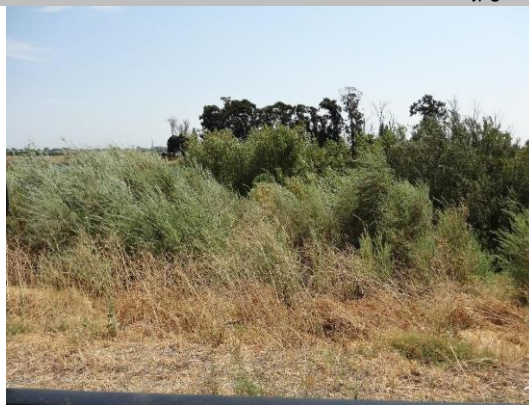
Photo 3 of 3 : UCIP\_SP\_2019\_50024\_75655.jpg

Dense vegetation on WS--unable to locate line.

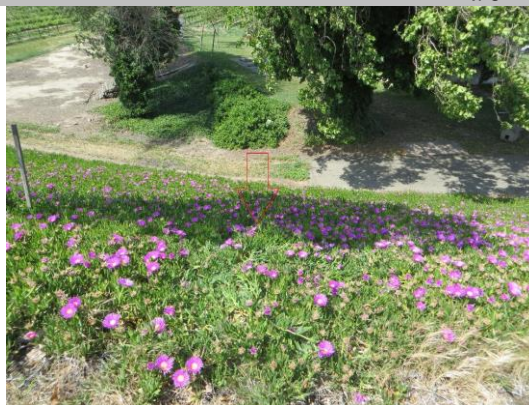
Photo 2 of 3 : UCIP\_SP\_2019\_44720\_73903.jpg

Mound at pipe visible on LS slope.

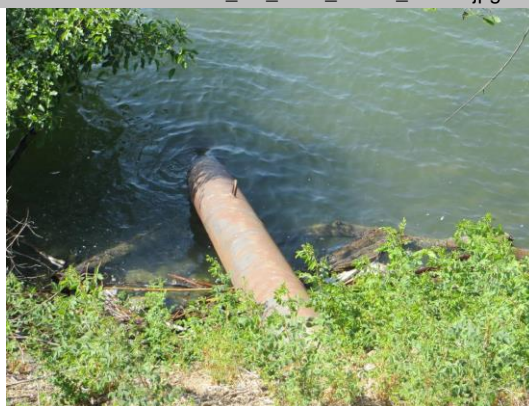
Photo 3 of 3 : UCIP\_SP\_2019\_44726\_73920.jpg

Pipe visible on WS toe.

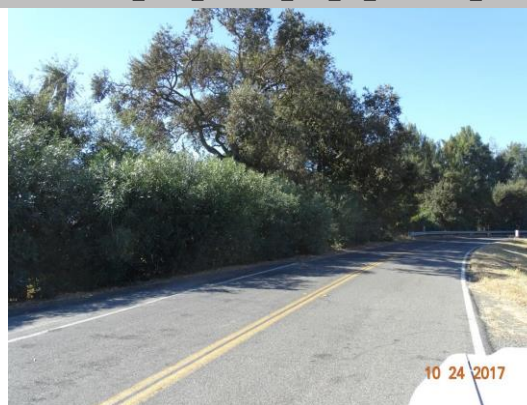
Photo 1 of 1 : SP\_2019\_RD0501\_169\_41\_20190311\_00009.jpg

View of trees/oleanders on the waterside slope.

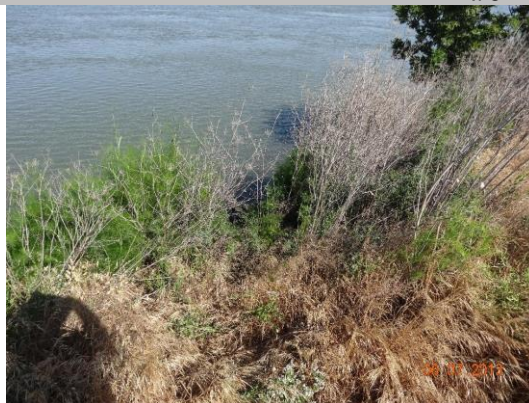
Photo 3 of 3 : UCIP\_SP\_2019\_53354\_58969.jpg

View of waterward side--dense vegetation limits inspection. Unable to locate pipe on waterward side.

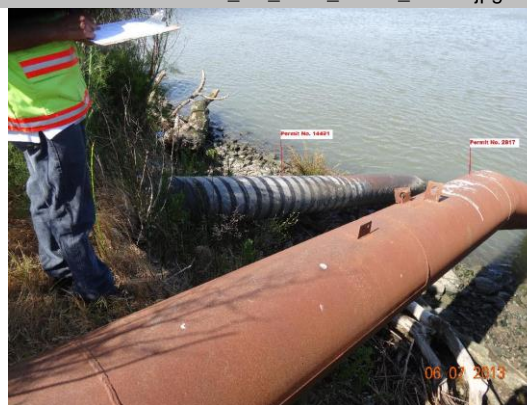
Photo 3 of 3 : UCIP\_SP\_2019\_44865\_58974.jpg

Waterward side--2-24 inch pipe inlets.

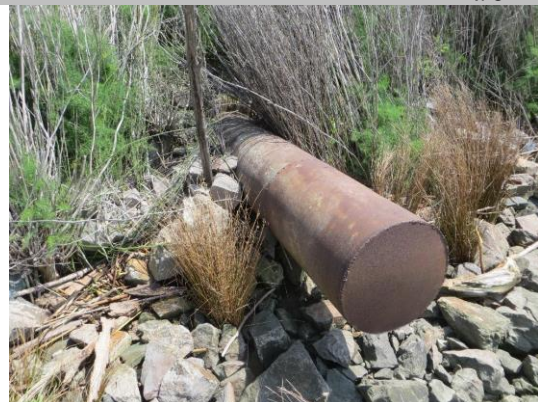
Photo 1 of 3 : UCIP\_SP\_2019\_44753\_73955.jpg

20-inch pipe with welded steel plate over end on WS toe.

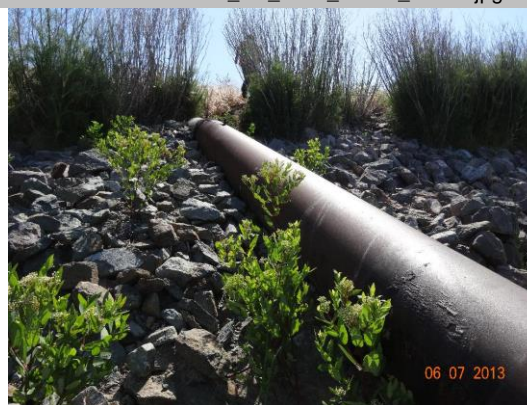
Photo 2 of 3 : UCIP\_SP\_2019\_44867\_58982.jpg

View of waterward side--pipe extends from berm to river.

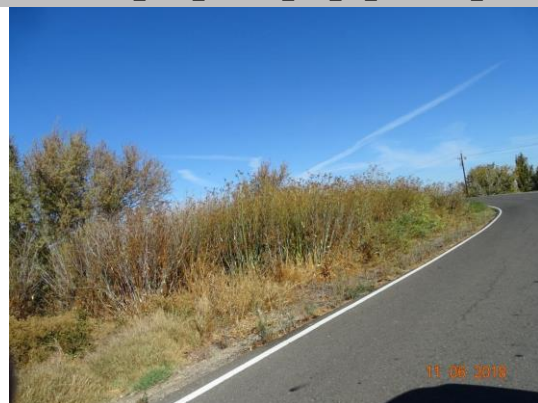
Photo 1 of 1 : SP\_2019\_RD0501\_170\_18\_20190311\_00003.jpg

View looking upstream at vegetation on the waterside shoulder (November 2018).

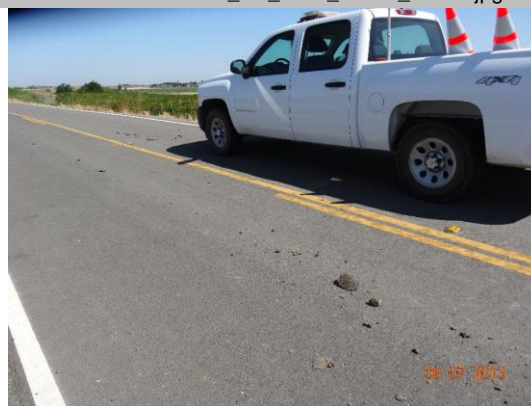
Photo 1 of 3 : UCIP\_SP\_2019\_32537\_58989.jpg

View of levee crown--narrow road.

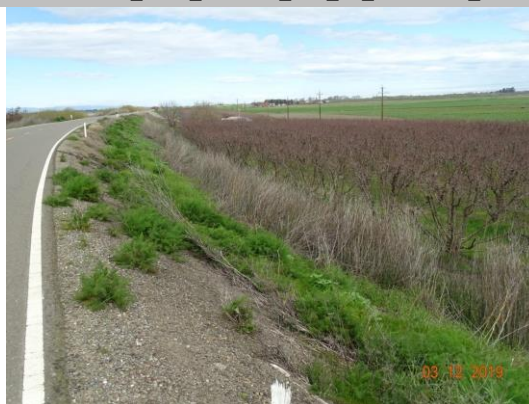
Photo 1 of 1 : SP\_2019\_RD0501\_170\_24\_20190314\_00045.jpg

View looking upstream at vegetation on the landside slope (Spring 2019).

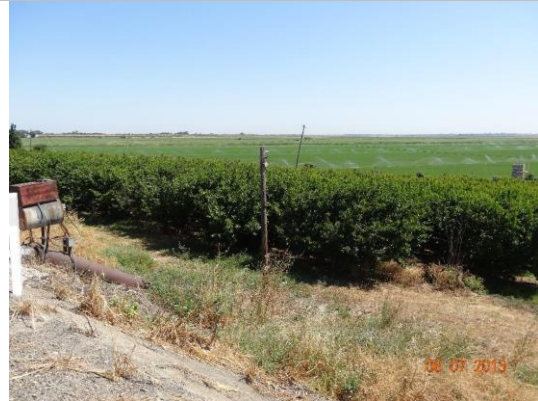
Photo 3 of 3 : UCIP\_SP\_2019\_44872\_33391.jpg

Overview of landward side. Pump system located near crown hinge point.

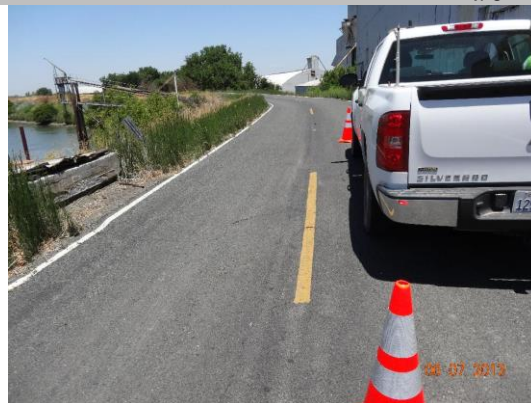
Photo 1 of 3 : UCIP\_SP\_2019\_32540\_59007.jpg

View of narrow levee crown.

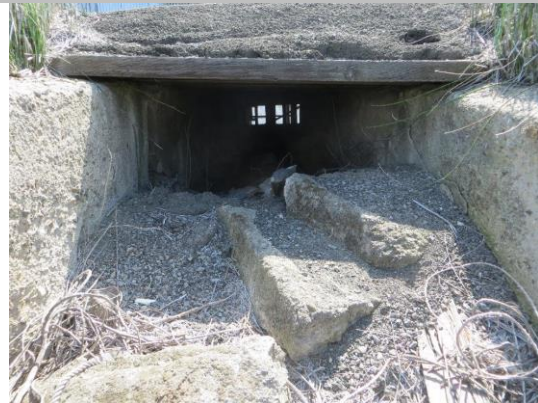
Photo 3 of 3 : UCIP\_SP\_2019\_53355\_73940.jpg

Tunnel open on both ends.

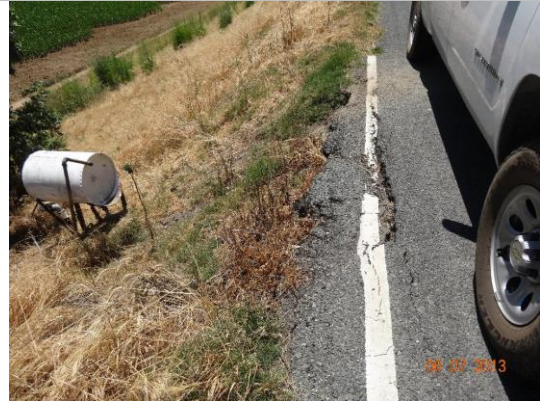
Photo 3 of 3 : UCIP\_SP\_2019\_44876\_33430.jpg

View of landward side. Dry vegetation covers landward slope. Pump system located on landward slope.

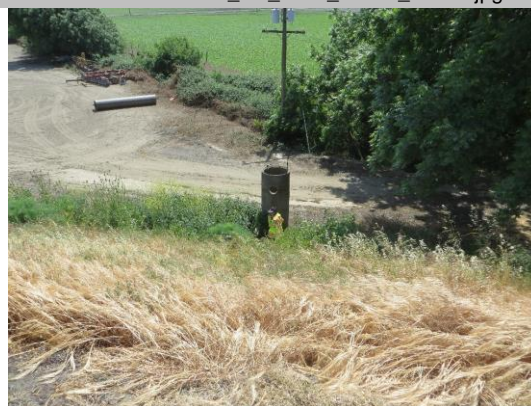
Photo 1 of 2 : UCIP\_SP\_2019\_44746\_73944.jpg

34-inch diameter concrete standpipe at LS toe.

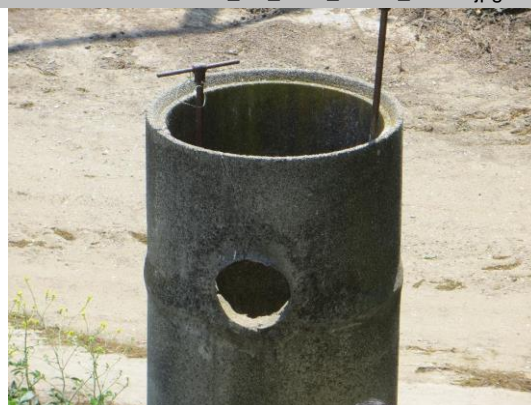
Photo 2 of 2 : UCIP\_SP\_2019\_44746\_73943.jpg

10-inch diameter hole cut in side of standpipe where pipe once was installed.

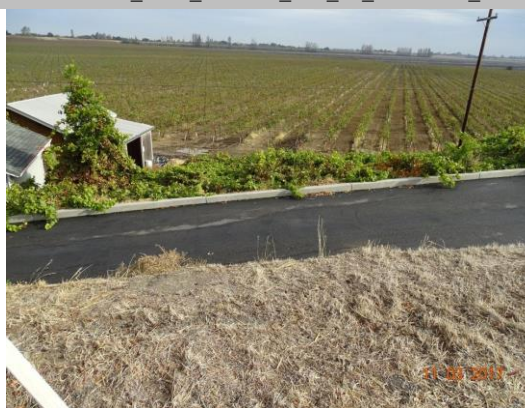
Photo 1 of 1 : SP\_2019\_RD0501\_171\_35\_20190311\_00006.jpg

Photo of landside landscaping (grape vines, bushes, trees)

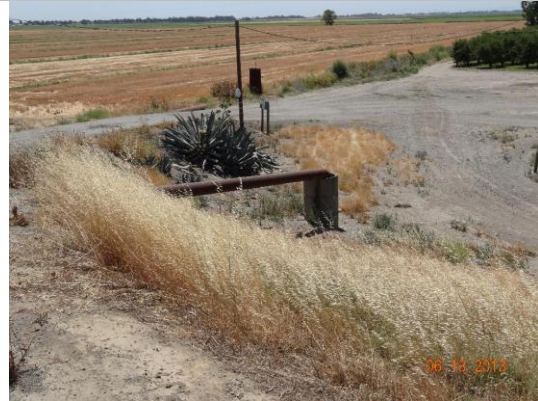
Photo 3 of 3 : UCIP\_SP\_2019\_32542\_59021.jpg

View of landward side. Pipe goes through levee and into concrete standpipe.

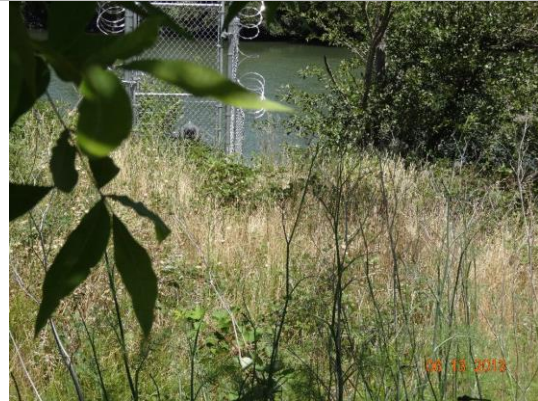
Photo 3 of 3 : UCIP\_SP\_2019\_46834\_33467.jpg

Pipe section near toe is protected by security fence.

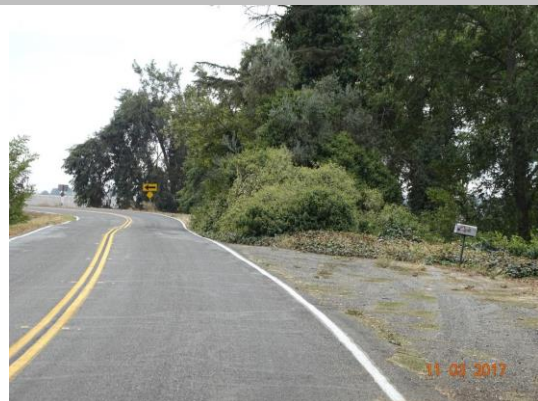
Photo 1 of 1 : SP\_2019\_RD0501\_171\_42\_20190311\_00010.jpg

Photo of landscaping on landside slope and toe

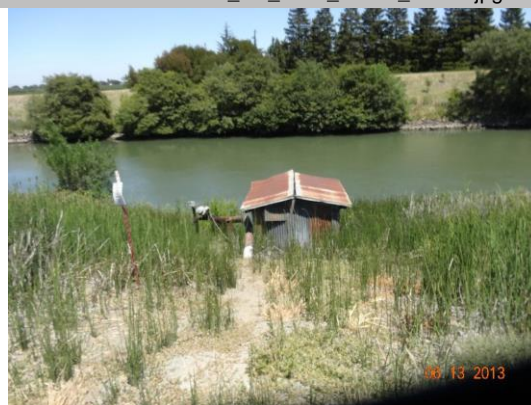
Photo 2 of 3 : UCIP\_SP\_2019\_32548\_59058.jpg

Overview of waterward side. Two crossings, 10 inch and 8 inch pipelines, less than 5 feet apart.

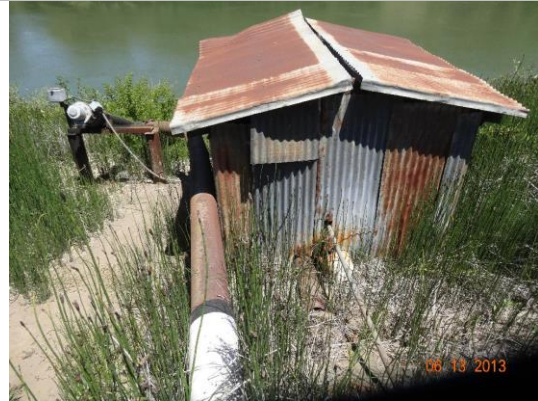
Photo 3 of 3 : UCIP\_SP\_2019\_32548\_59056.jpg

Pump house is associated with abandoned 8 inch pipe.

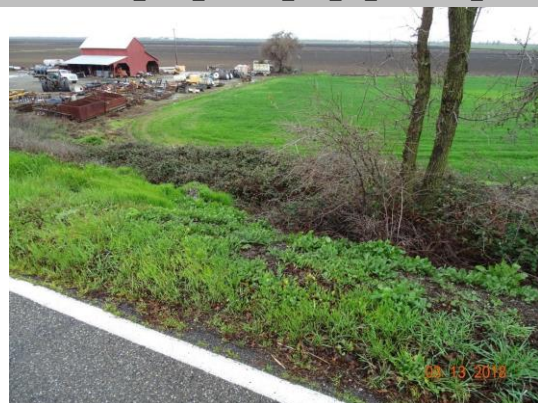
Photo 1 of 1 : SP\_2019\_RD0501\_172\_11\_20190311\_00001.jpg

Thick blackberries should be removed.

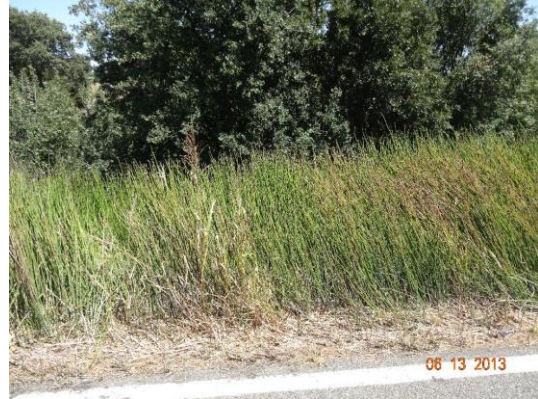
Photo 3 of 3 : UCIP\_SP\_2019\_53356\_59064.jpg

High vegetation along waterward side.

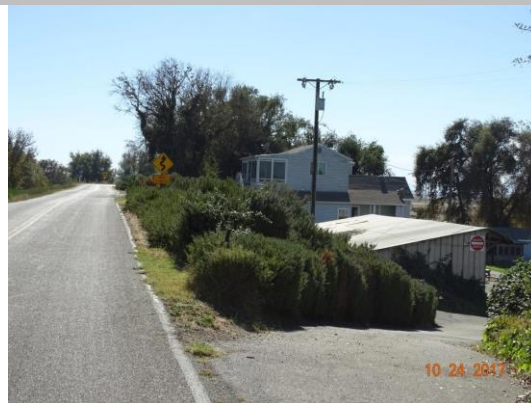
Photo 1 of 1 : SP\_2019\_RD0501\_172\_17\_20190311\_00005.jpg

View of landside landscaping on levee slope
